Manhole Inspection Summary

Manhole # S69U__007MH

Location Address: **6422 Holabird Ave.**

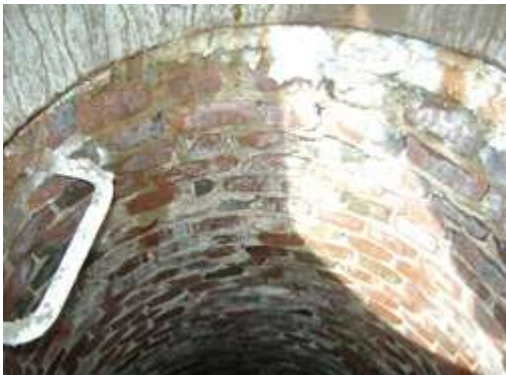
Defect 4

Infiltration: ☐ None ☒ **Joint** ☐ Cracks ☒ **Mortar** ☐ Roots ☐ Wall

Infiltration-mortar joints of the chimney to barrel

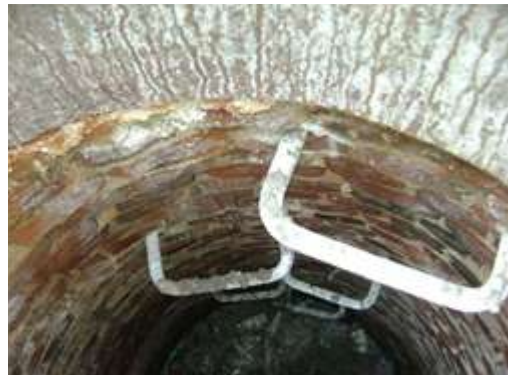
Defect 3

Condition: ☐ Sound ☐ Cracked ☐ Root Intrusion ☒ **Loose Brick** ☒ **Deteriorated**

Loose Bricks-chimney

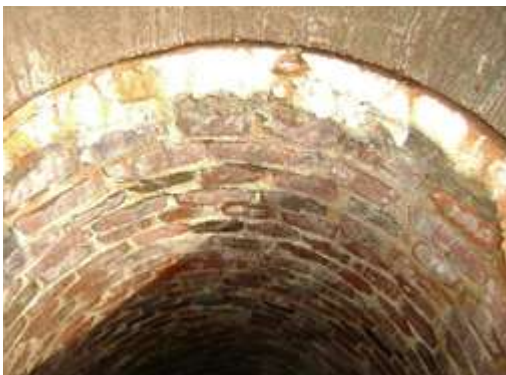
Defect 2

Deterioration--chimney

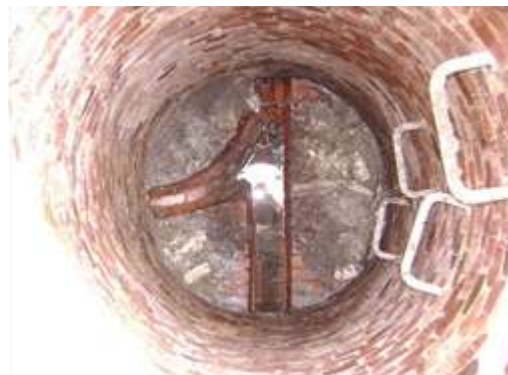
Defect 1

Condition: ☐ Sound ☐ Cracked ☐ Root Intrusion ☐ Deteriorated ☐ Leaks ☒ **Debris**

Debris

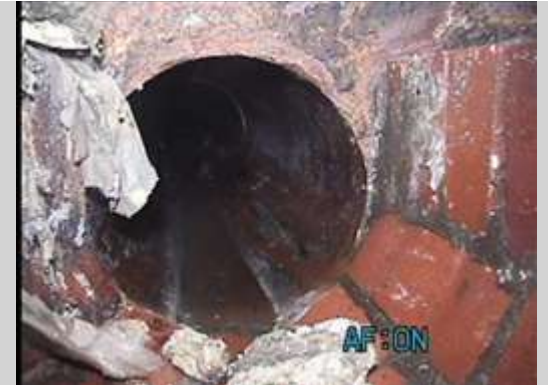
12 O'Clock Outflow

8 in. Circular Gravity Sewer
Pipe Out @ 12 O'Clock

Pipe Height: **8.4** (in.) Rod and Bar (Angled)
Pipe Material: **Clay** ☐ Pipe Lined
Invert Depth: **9.33** (ft.) Flow Characteristics: **Slow**
Deposits: ☒ None ☐ Mud ☐ Sludge ☐ Debris ☐ Grease
Silt Depth: (in.) Deposits Extent:
Infiltration: **None** Pipe Seal Cond: **Sound**

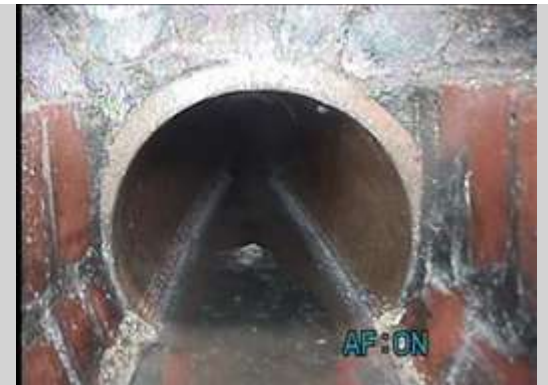
6 O'Clock Inflow

8 in. Circular Gravity Sewer
Pipe In @ 6 O'Clock

Pipe Height: **8.4** (in.) Rod and Bar (Angled)
Pipe Material: **Clay** ☐ Pipe Lined
Invert Depth: **9.17** (ft.) Flow Characteristics: **Slow**
Deposits: ☒ None ☐ Mud ☐ Sludge ☐ Debris ☐ Grease
Silt Depth: (in.) Deposits Extent:
Infiltration: **None** Pipe Seal Cond: **Sound**

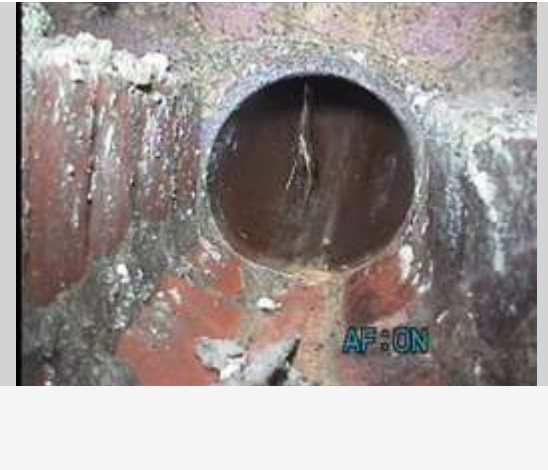
9 O'Clock Inflow

6 in. Circular Gravity Sewer

Pipe In @ 9 O'Clock

Infiltration: **None**

Pipe Seal Cond: **Sound**
